OPERATING EXPERIENCE WEEKLY SUMMARY

Office of Nuclear and Facility Safety

July 9 - July 15, 1999

Summary 99-28

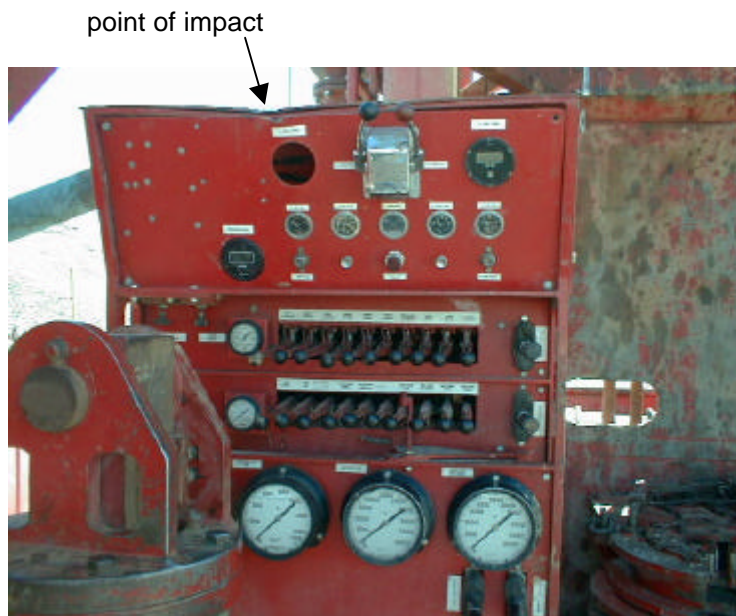
At the time of the occurrence, a drilling subcontractor was operating an LM 300 drill rig to install four deep monitor wells, ranging in depth from 1,300 to 4,000 ft. The wells are to supplement monitoring wells that were installed following a 1963 underground nuclear detonation at the Project Shoal Area. A drilling subcontractor crew consisting of a drill operator and his assistant, an operator trainee, were preparing to remove a drill rod from the borehole for one of the wells to check the bit for wear. A hose cylinder line on the drill rig mast was supporting the discharge line from the assembly to provide the clearance needed to remove the drill rod. The operator, who was handling the discharge line from the drill platform, instructed his assistant to raise the hose cylinder line. However, the assistant operated the lever for the idle sand line by mistake. The ball-and-hook assembly on the sand line contacted the boom tip and the resulting strain parted the cable. The operator and his assistant immediately cleared the area. The ball and hook glanced off support structure for the drill rig mast, struck the operator's console, and fell to the drill platform 6 ft from the console. The impact caused a depression of about 1 in. in the 1/4-in. steel console cover (Figure 1-1).

Figure 1-1. Damage to LM-300 Drill Rig Operator's Console

- The ball-and-hook assembly was approximately 20 ft from the boom tip before the occurrence. By the time it contacted the boom tip it was too late to stop the winch.
- The sand line is not equipped with a high-load cutout to prevent two-blocking.
- The sand line winch is rated for 10,000 lb, and the line pull rating of the cable is 31,200 lb. The cable failed because it had kinked as it passed through the sheave at the boom tip.

Site personnel have repaired and inspected the drill rig and returned it to service.

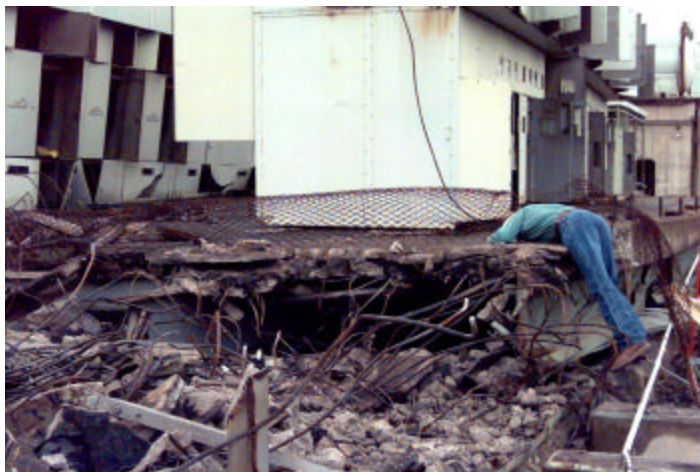
trackhoe/shear operator noticed an increase in tension in the load. As the ironworker apprentice attempted to climb down off the slab, the fence pulled free from the obstruction before the trackhoe operator could stop the rotation and the trailing end flew over the boom and shear and struck the apprentice on the back of the head. The ironworker apprentice was knocked unconscious and fell face down onto the slab. Figure 1-1 shows a view of the accident scene.

Figure 1-1. View of Accident Scene with Worker Reenacting the Injured Ironworker¹

The Accident Investigation Board determined that the work plans to remove the bus bars and perform the demolition were developed as independent tasks with task hazard analyses that prohibited other operations in close proximity or in adjoining areas. The Board also identified several contributing causes that may have increased the likelihood of the accident without individually having caused it. These contributing causes follow.
